920XC Trace Viewer Interpretation

VER 1.1

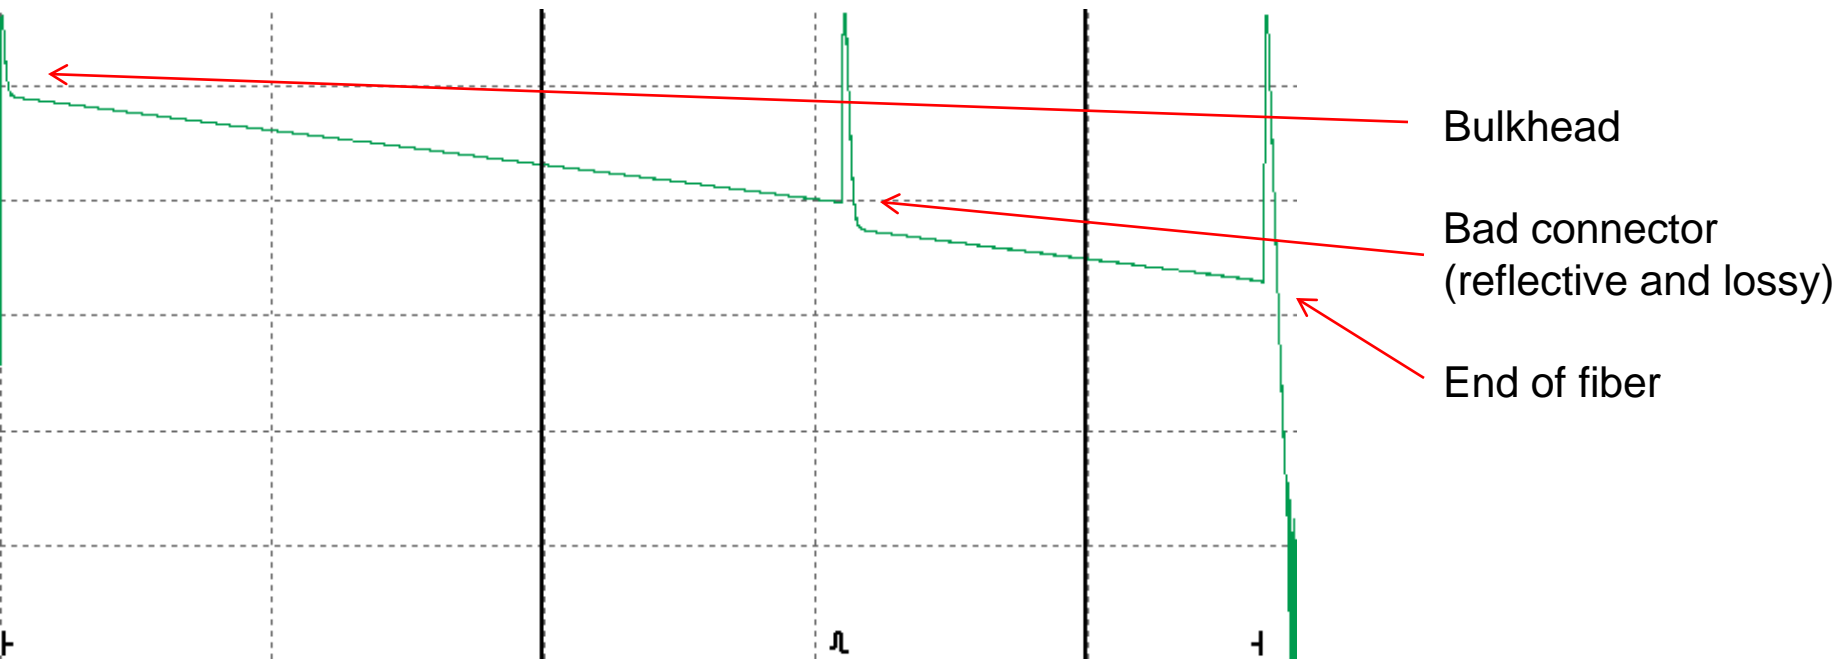
Event Table								
No.	Type	Locatio...	Refl.[dB]	Ins.Loss[dB]	Attn.[dB/km]	Cum.Loss[dB]	Dist.Prev.[km]	Dist.End[km]
1	Start	0.0000	-46.107	-,---	-,---	-,---	-,---	37.9391
2	Refl.	25.2757	-35.711	1.091	0.184	4.643	25.2757	12.6634
3	End	37.9391	-29.008	-,---	0.186	8.093	12.6634	-,---

Bulkhead
Bad connector
End of fiber
